# Manhole Inspection Summary

Manhole # S21II\_061MH

Insp Date: **6/22/07 10:37 AM**

**Location** Address: **1801 MCKEAN AVE**

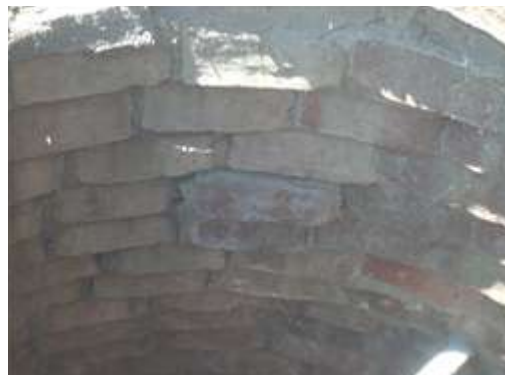
Defect 3

**Corbel** Material: **Brick** ☐ Parged Type: **Concentric/Eccentric**

Condition: ☐ Sound ☐ Cracked ☐ Root Intrusion ☒ **Loose Brick** ☒ **Deteriorated**

LOOSE CORBEL BRICKS

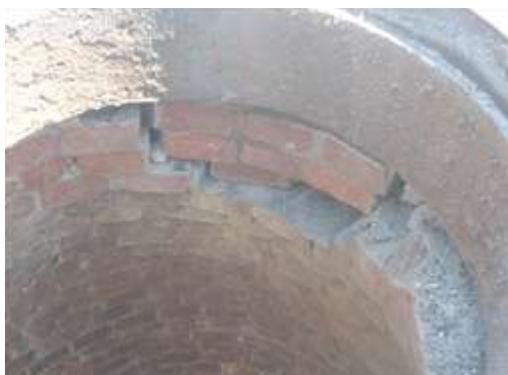
Defect 2

MAJOR DETERIORATION OF CORBEL

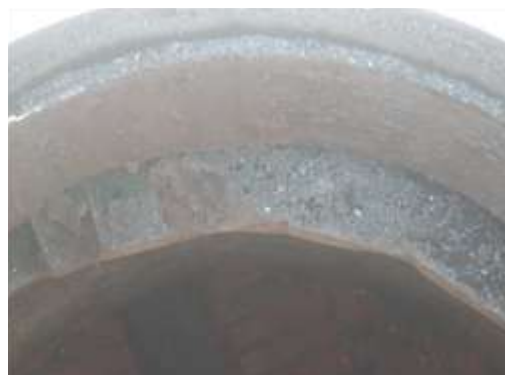
Defect 1

**Frame** Offset: **3** (in.) Condition: ☒ Sound ☐ Cracked ☐ Leaks

FRAME OFFSET

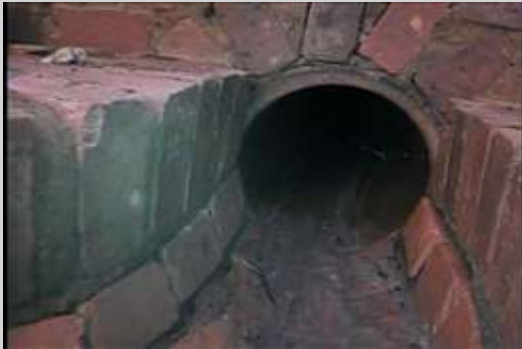
12 O'Clock Outflow

8 in. Circular Gravity Sewer  
Pipe Out @ 12 O'Clock

Pipe Height: **8.4** (in.) Rod and Bar (Angled)  
Pipe Material: **Clay** ☐ Pipe Lined  
Invert Depth: **8.84** (ft.) Flow Characteristics: **Fast**  
Deposits: ☒ None ☐ Mud ☐ Sludge ☐ Debris ☐ Grease  
Silt Depth: (in.) Deposits Extent:  
Infiltration: **None** Pipe Seal Cond: **Sound**

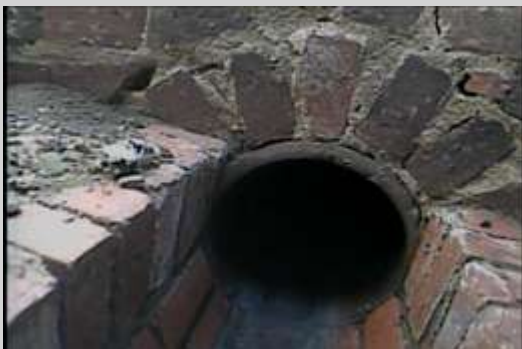
9 O'Clock Inflow

8 in. Circular Gravity Sewer  
Pipe In @ 9 O'Clock

Pipe Height: **8.4** (in.) Rod and Bar (Angled)  
Pipe Material: **Clay** ☐ Pipe Lined  
Invert Depth: **8.59** (ft.) Flow Characteristics: **Fast**  
Deposits: ☒ None ☐ Mud ☐ Sludge ☐ Debris ☐ Grease  
Silt Depth: (in.) Deposits Extent:  
Infiltration: **None** Pipe Seal Cond: **Sound**
